PROPAGATION TESTING OF M61 ROCKETS
IN SINGLE ROUND CONTAINERS

D.B. HILL Ammunition Equipment Directorate Tooele Army Depot, Utah

Presented at:
TWENTY-SECOND DOD EXPLOSIVES SAFETY SEMINAR
Dept. of Defense Explosives Safety Board
Anaheim, California

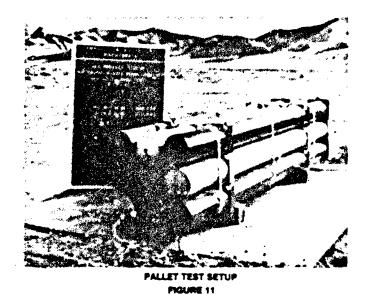
M61 ROCKET MODIFICATIONS FIGURE 16

The pallets, or single packages, were configured, colored, and numbered as shown in Figure 11. The donor, or central rocket was modified as described for the baseline test rockets. The eight acceptor rockets, for the first test only, were prepared as follows (see Figure 10). The fuze adapter was modified to allow insertion of a piezoelectric blast pin against the M36 burster. The blast pin was held tightly against the burster by attaching its electrical lead to a short length of wire rope with shrink-fit tubing, and then clamping the assembly to the fuze adapter with a hose clamp. The electrical lead was passed through the existing inspection hole in the fiberglass container's

endcap and then through a hole drilled in the dome end of the SRC. An ionization probe (to detect motor ignition) was inserted into a void in the M28 propellant grain, near the vicinity of the black powder igniter charge; and its electrical lead passed through inspection ports in the fiberglass container endcap and the SRC flanged end. The blast pins were not used for the next two tests because of a false indication of propagation given in the first test. The ionization probes were determined to be unnecessary instrumentation because visual inspection would reveal if a motor initiated. The threads were machined from the fin-nozzle assembly in all rockets for all tests to preclude propulsion in event of motor ignition. The rockets were then placed in SRC and the flanged end plates secured with the nuts tightened to 20 ft-lbs. The nine SRC for each test were palletized and bended in three locations with 3/4" banding. The pallet was then placed on wooden 4 x 4s on a witness plate, oriented as shown in Figure 11.

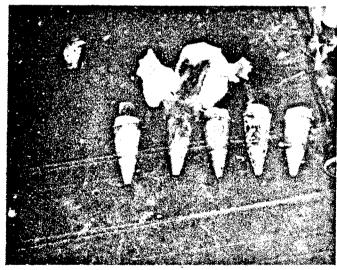
TYPICAL PALLET TEST RESIDUE FIGURE 15

Fragmentation patterns and distances appeared to be similar to those in the 1977 tests except that more fragments were recovered in those tests. The majority of fragments in both series (1977 and current) were in a 200-600 ft. radius of ground zero, and to the east and west of ground zero. One piece, in the recent series, was found at 1190 feet. The greatest distance recorded in the 1977 test report was 1030 feet. There was a greater scattering of major components (SRC, shipping/firing container, motor casing) around ground zero in the current series of tests. Figure 15 shows that significant damage was incurred by all the acceptor SRC. The motor half of the SRC generally remained intact with the motor housing and propellant grain staying within the SRC while the warhead half was totally destroyed. In all three tests the acceptor immediately beneath the donor remained completely assembled; i.e. the entire rocket remained within the SRC. The warhead and warhead end of the SRC were flattened and ruptured; and the burster burned up completely within the warhead.
